**ASSESSMENT AND REMEDIAL MEASURES OF ROAD FAILURE  
A CASE STUDY ALONG ADAMA-ASSELA TRUNK ROAD**

**MSc Thesis**

**DEPARTMENT OF CIVIL ENGINEERING (GEOTECHNICAL  
ENGINEERING STREAM)**

**COLLEGE OF CIVIL AND ARCHITECTURAL ENGINEERING  
ADDIS ABABA SCIENCE AND TECHNOLOGY UNIVERSITY**

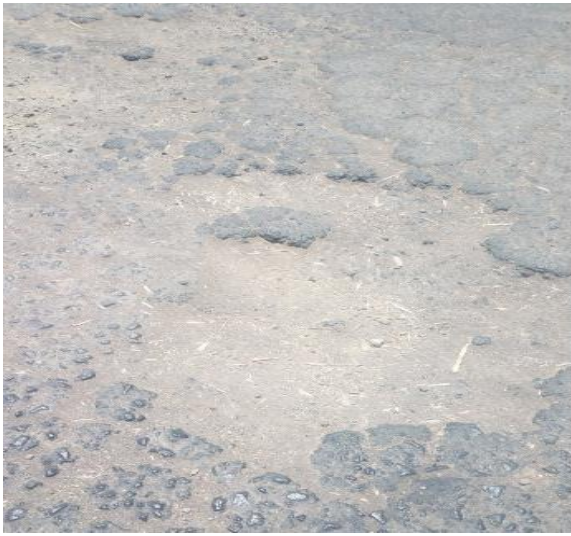
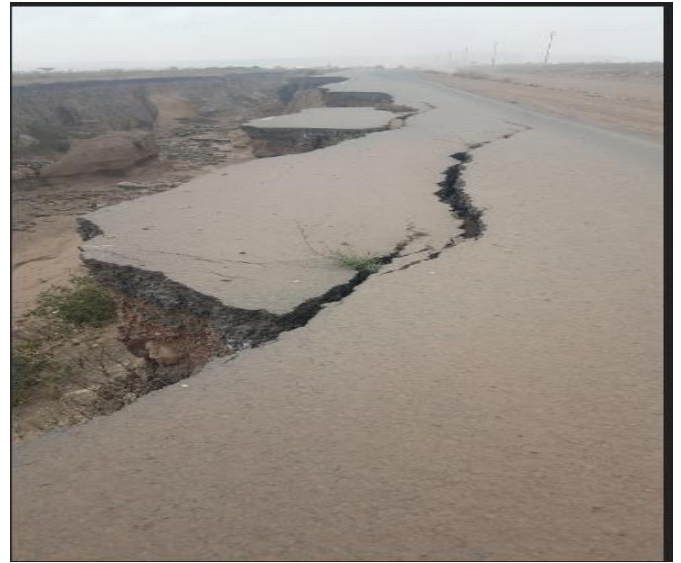
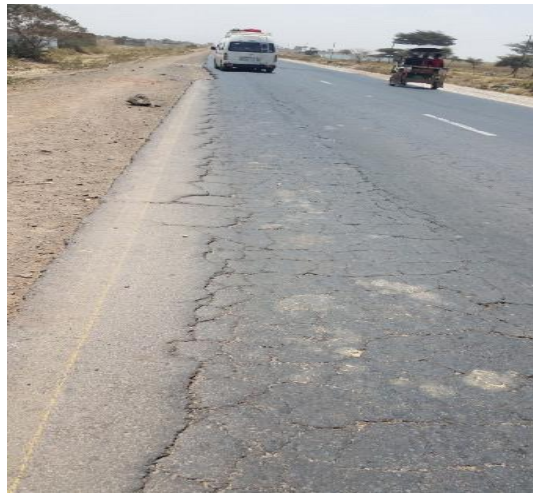
Figure 4.1(a),(b) and (c): Road condition of the failed section

Road Section	Chainage		Remark
	From	To	
Uniform Section 1	5+200	8+650	Minor distresses [Severity-level-1)
Uniform Section 2	9+700	15+150	Intermediate Distress (Severity- level 2)
Uniform Section 3	15+150	41+500	Severely Distressed areas ( Severity -level-3)

Longitudinal Cracks are parallel slits to the pavement's centerline; these cracks are structural defects (weakness of paving layer) and Functional defects (roughness of the paving surface). The loads and moisture accelerate the deterioration of these cracks

Minimum numbers of Potholes were observed on the roads section. However, the appearance of Potholes shows failure on base or subgrade due to poor drainage or due to structural deficient pavement. Moreover, the intrusion of water to the pavement through the cracking or ponding of water on the rutting of pavement may cause pothole creation.

The analysis indicates that there is type of rutting failure along the study area this failure type is mainly due to the low-quality subgrade materials it can be concluded that some part of the road section severely affected by rutting. This failure type is mainly due to the low quality subgrade materials as and mostly due to excessive traffic loading above the design values.
