APPRAISAL OF DESIGN PRACTICE AND FAILURE OF RIVER DIVERSION FOR
IRRIGATION SCHEMES: A CASE OF WADLA WOREDA NORTH WOLLO,
ETHIOPIA

M.Sc. THESIS

KUMNEGER DESALEGN

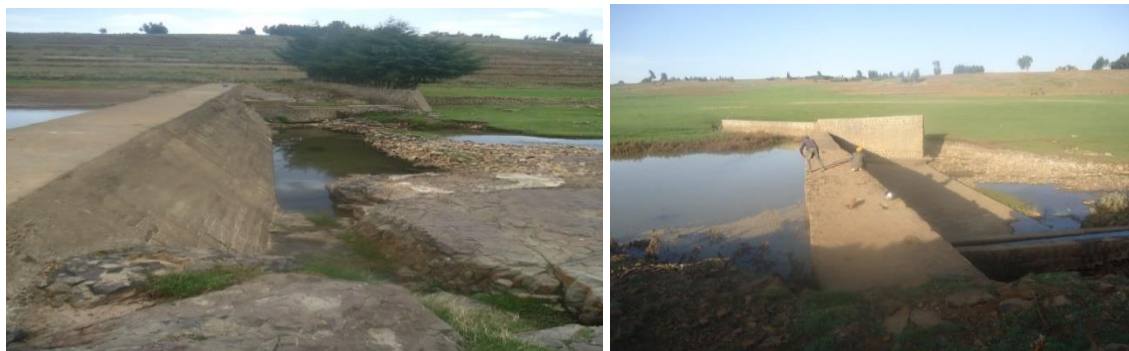
Before a specific project, there is no implemented and planned in a basin master plan for the use of water resources in the basin has to be established. In this study area usually the site investigation and planning activity were worked by the team of agriculture and rural development experts. The design practice in some of the studied schemes there is no include all part of the structures, like retaining wall, cut off, under sluice, divided wall and stream basins. Those problems occurred do to conflict, selected site is very wide and flat, lack of knowledge, and a large stone around the cross section of the weir.

Figure 4.1 Kendbersha and Fiadiango_1 weirs constructed without under sluice and divide wall

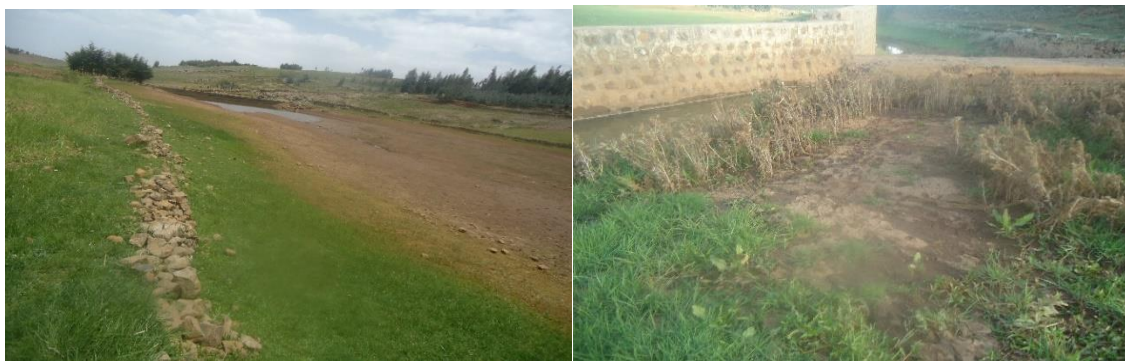
The problem of sedimentation involves the diversion of head work. As stated above the other function of diversion headwork is to control entry of silt into the canal. The consequently indicated that 41.94% of a diversion head-work faces accumulation of high silt load at the head regulator, high sediment entry to the main off taking canal. The bed load consists of solids such as fine sand, gravel with a small diameter of up to about 2mm, or coarse material (gravel, stones of various sizes).

Figure 4.3 Silted-up head work structure Kendbersha and Fiadiangoa_1 schemes

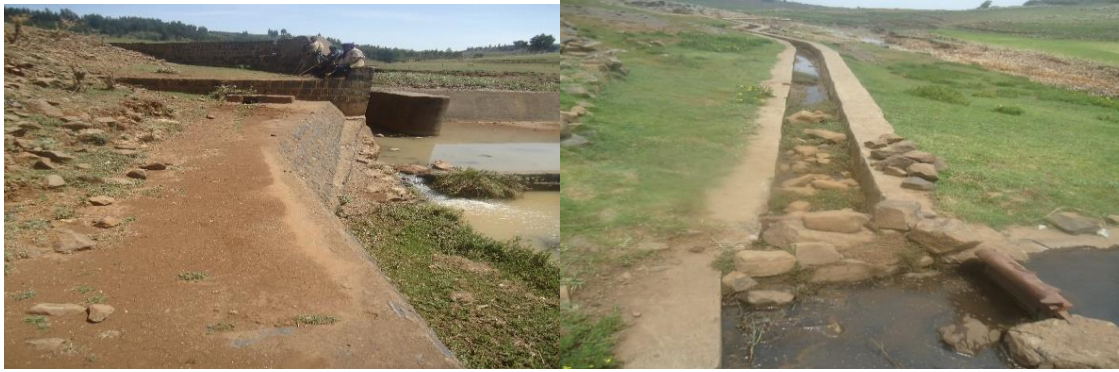
While as the field observation the main canals were highly charged with sediment (22.58%) like, Kendbersha, Ydogite and Yneja irrigation schemes are to suffer the problem. The silt load is observed to come either along with the river water (suspended and bed load) or as a run-off from the upstream nearby catchment. A lined canal Ydogite and Kendbersha diversion irrigation scheme completely filled with sediment (Figure, 4.4), the hidden canal section has insufficient space for farmers to move through it and clear the deposited sediment. So, maintaining the canal requires first routing the buried canal and then clearing the sediment. Though there were efforts started, it has not been successful since it demanded to mobilize both financial and human resources for proper understanding and improving the problem.

Figure 4.4 Silted-up canals Ydogite and Kendbersha irrigation schemes

Some canals do not have a proper design slope. In addition to these the canal in this reach passes in a deep cut, the soil bank immediately beside the canal is not stable. It is vulnerable to be washed by the rainwater and deposited into the canal. Hence, deposition of large soil mass should not be allowed to break beside the canals, but adequate edges should be provided.

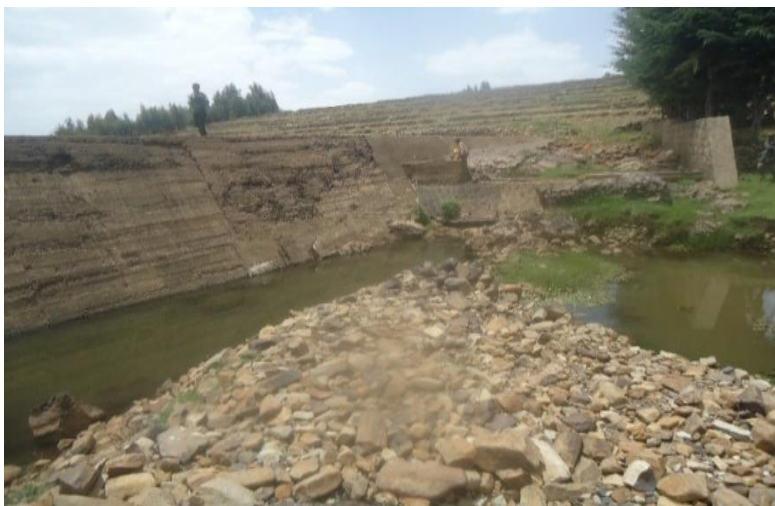
When the natural waterway of the river is contracted, the waterway scours the bed both on upstream and downstream of the structure. These phenomena occurred when there is a high flow of water over the structure without the design of the hydraulic jump. The scour whole forms progress towards the structure cause its failure. These problems occurred were 24.49% of Kendbersha and Yneja irrigation schemes. Failure of weirs on permeable foundations occurs as a result of the scouring of the downstream floor of the structure. It is due to unbalanced pressure in the hydraulic jump. Weirs constructed on impervious foundations are rare since most irrigation projects locate at or near the alluvial stage of rivers. In the subsequent sections some approaches for assessing the uplift pressure in pervious foundations and limitations on their application are discussed. In addition the above discussion these structures is have not constructed stream basin and under sluice parts. Therefore to prevent the failure of this structure the piles should be provided at the upstream and downstream of the structure.

Figure 4.5 Downstream scoring Kendbersha irrigation scheme

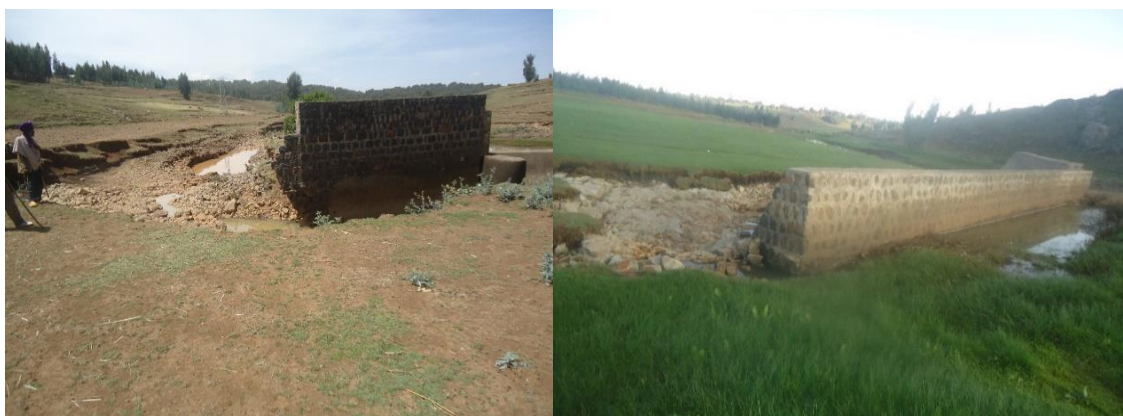
Damage on the head work refers to those damages to the weir body, including the downstream bed, retaining walls and protection works. Damage on the weir retaining walls is observed in 2 of the total schemes. As field observed that 30.61% of collapsed wings and eroded protection works. In the diversion schemes where this problem succeeds, cut and scouring of the impervious floor are commonly observed. In addition, flexible aprons (protection works) are seen to be completely washed away by the energy of flowing water. The prolonged occurrence of cut and scouring of downstream portion of the structure may end up in the total collapse of the structures. This could be prevented by providing cut-off wall just at the end of the protected work.

Figure 4.6 Damage on the retaining wall of Fiadiangoa_2 and Ydogite schemes

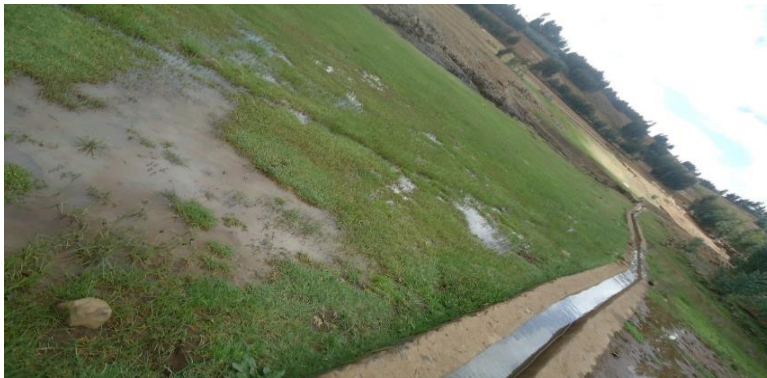
The seepage problem can be categorized into Main canal seepage and Weir body/foundation seepage. The problem of main canal seepage is observed on 3 of the total studied schemes considered for the analysis. It is the most common problems observed in most of the schemes. The seeping water is seen to flood out under of the soil and to the sides. Hence, significant quantity of irrigation water is lost before arriving to the distributing canals. By the loss of valuable diverted water, the seepage moisture is creating water logging of the adjacent lands. The cracks formed in the canal act as a conduit to pass the water into and from the irrigation canal depending on the water level in the canal. The following picture shows the seeping water into the canal.

Figure 4.7 Yneja diversion irrigation scheme

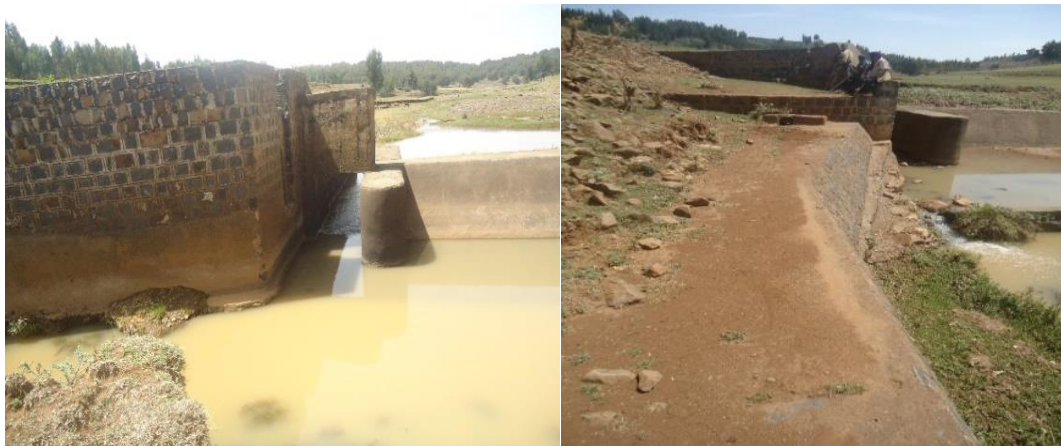
The cause for the problem of damaged gates is mainly improper scheme operation and the others are in case of high flood around the construction. The design document and filed survey work critically viewed that the design practices of the existing weir structures. Therefor in some schemes like Kendbersha and Fiadiogoa_1 irrigation schemes are the parts of under sluice and divided wall are not constructed, by these case during the high water flow of the river the canal outlet gates are damaged.

Figure 4.8 Damage on intake gate and under sluice Ydogite schemes

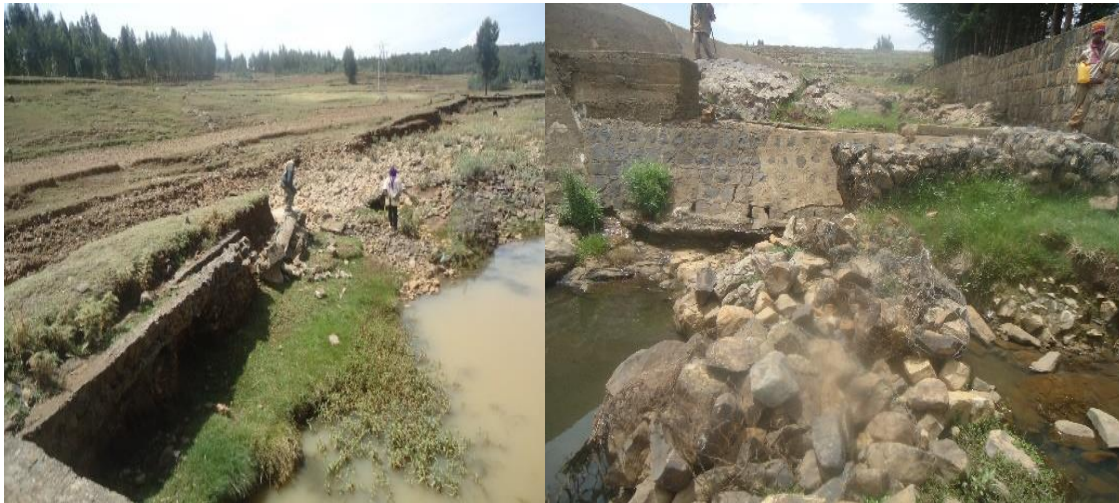
This damage occurred in 4 schemes out of the total considered schemes for the analysis. During the rainy season river flows accomplished large amount of sediment for the cause of scouring and loses the formation of the foundation for the canal. The main canal running within the river course until it leaves the course is highly affected by the unstable geological condition of the river bank. The causes for this problem are associated with the diversion site selection and the absence of the protection works aligned along the canal.

Also lack of consideration in the hydraulic design to incorporate cut-off wall d/s of the diversion structure leaves open space subjected to progressive scour by the flowing water.

Figure 4.9 Damage on main canal Ydogite and Kendbersha
