**ASSESSMENT AND REMEDIAL MEASURES OF ROAD FAILURE  
A CASE STUDY ALONG ADAMA-ASSELA TRUNK ROAD**

**MSc Thesis**

**DEPARTMENT OF CIVIL ENGINEERING (GEOTECHNICAL  
ENGINEERING STREAM)**

**COLLEGE OF CIVIL AND ARCHITECTURAL ENGINEERING  
ADDIS ABABA SCIENCE AND TECHNOLOGY UNIVERSITY**

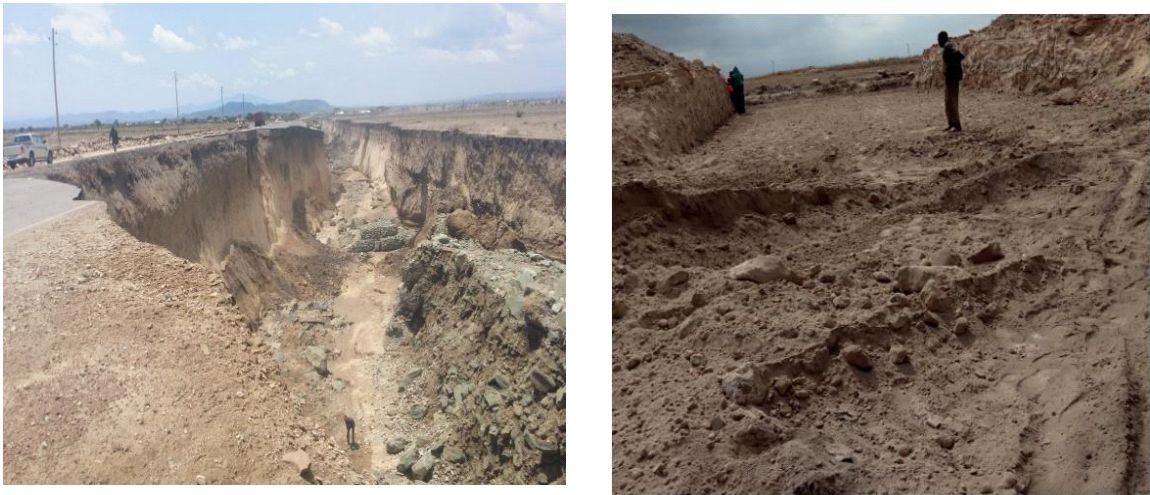
Figure 3.3: Geology of the route corridor

The study area is found in south central part of the country at the verge of the Eastern Plateau and the Main Ethiopian Rift system. The area is found making the shoulder of the rift from the east direction with an elevation of ranges from 1600m to 2000m amsl. The gully hazards are mainly observed starting from Sodera junction up to Iteya town. The main features of this area include flat morphology with frequent appearance of greyish silty sand soil. The geological formation of the study area is mainly covered by quaternary sediments of lacustrine origin. Lacustrine beds are interbedded with plio-pleistocene. Lacustrine beds are mostly redeposited volcanic sand and tuff with calcareous material and diatomite. According to Mohr.(1966) at the beginning of the Quaternary an ancestral lake which was almost certainly continuous from south to Awash basin to the north existed until it shrinks to the smaller ones by late Pleistocene tectonic movements. As observed during the site investigation, the lacustrine deposit found in study area is greyish to whitish silty sandy soil. Moreover, gypsiferous and fossiliferous limestone of lacustrine origin is observed in study area.

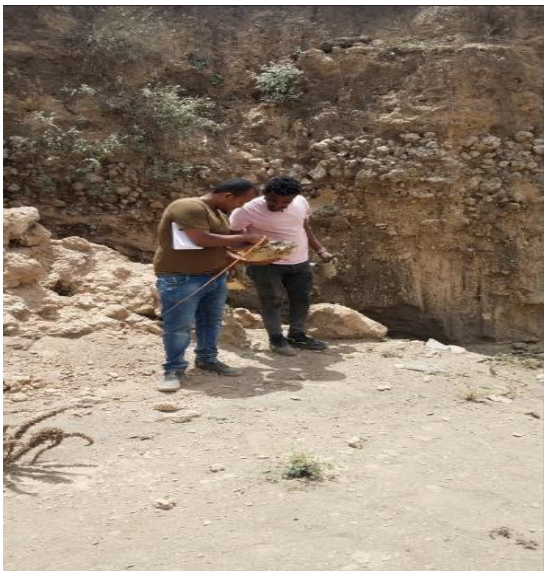
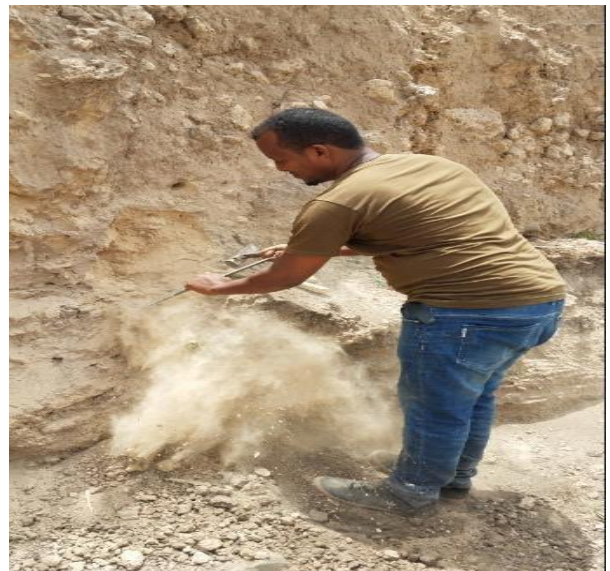
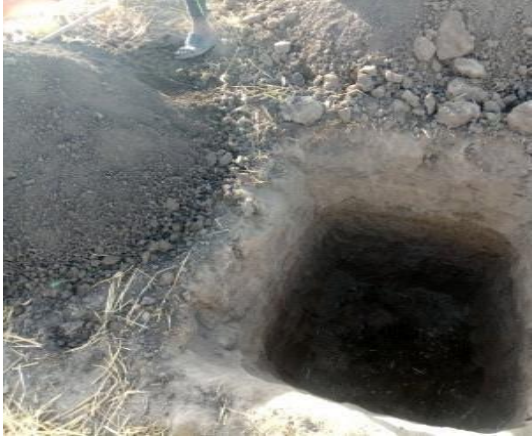
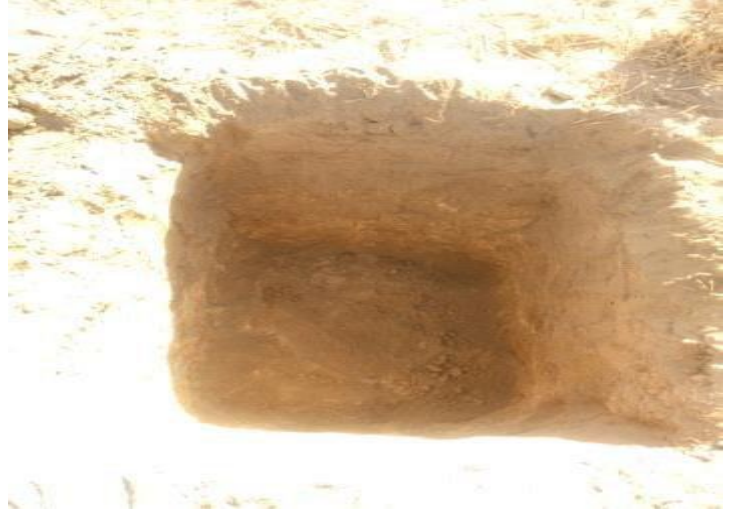
Figure 3.4(a), (b), (c) and (d) Soil survey and sampling

Field investigation of the existing pavement condition has been conducted in order to identify the type and extent of the pavement failure. Test pit excavation and sampling of soil for laboratory test performed to identify the major pavement failure .In addition; it provided valuable site information that has an influence on the best remedial option.

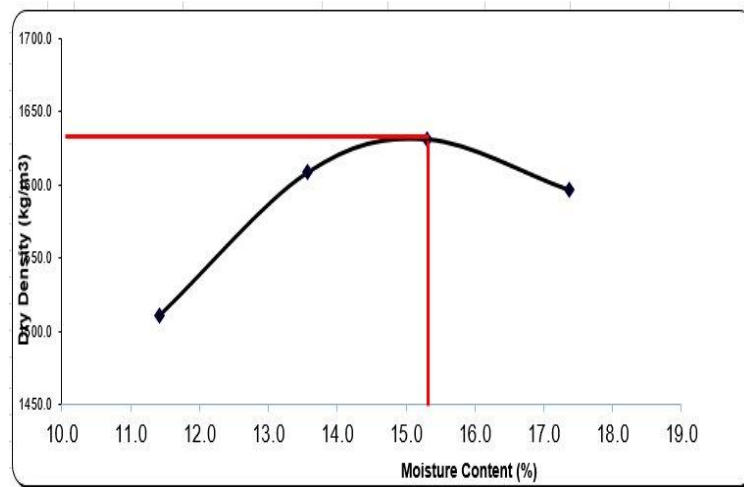
Figure 4.4: Moisture versus dry density curve

The optimum moisture content of the sampled subgrade soil as obtained from the laboratory is 15.3%. Whereas the maximum dry density value of 1632kg/m<sup>3</sup>.

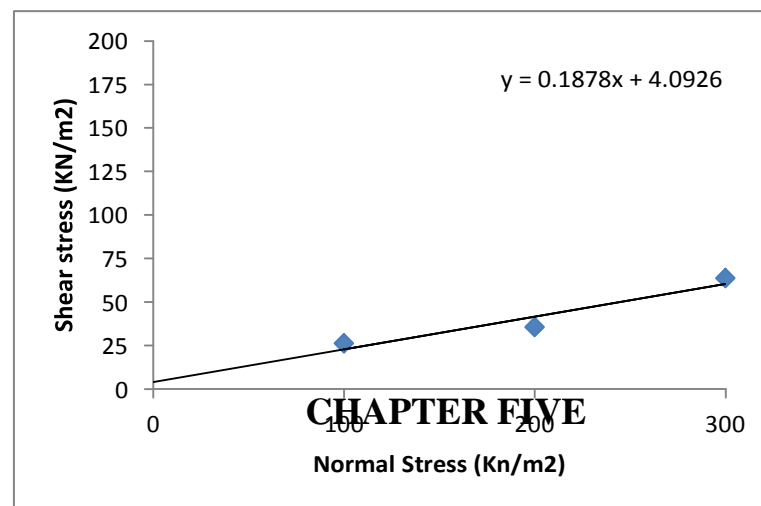
Figure 4.8: Direct Shear graph for soil sample no 3

The tested samples recorded reasonably low values of cohesion ( $c$ ) with moderately high values of angle of shearing resistance ( $\phi$ ). Low  $c$  could result from the silty nature of the soil, while the high  $\phi$  is attributable to cohesionless nature of the soil.
