ADDIS ABABA UNIVERSITY SCHOOL OF GRADUATE STUDIES DEPARTMENT OF CHEMICAL ENGINEERING (Environmental Engineering Stream)

Study of the Urban Drainage System in Addis Ababa, Yeka Sub-city.

A Thesis Submitted to the School of Graduate Studies of Addis Ababa University in Partial Fulfillment of the Requirements for Master's of Science in Environmental Engineering

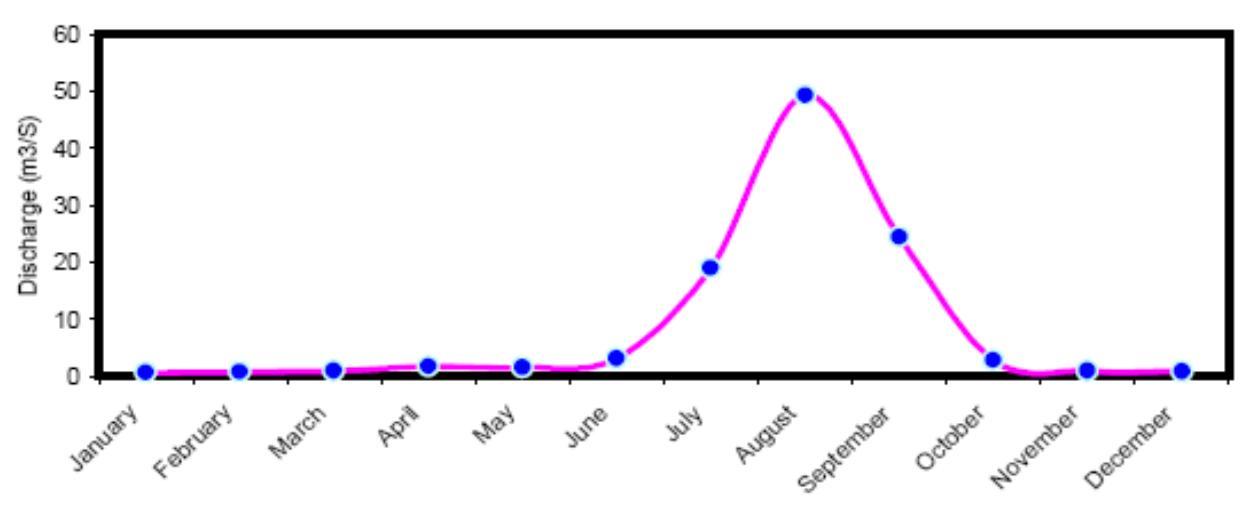
Fig-2.1 Mean monthly flow of Big Akaki river (source: Addis Ababa University, 2003).

According to Figure 2.1, the mean monthly flow of Big Akaki River Hydro-geological investigation which was carried out in the Akaki area by AAWSA-THAL (1992) showed that from the total water supplied to Addis Ababa about 70% returns as waste water and 60% of the return is discharged to Big Akaki river and the remaining 40% to the Little Akaki river.

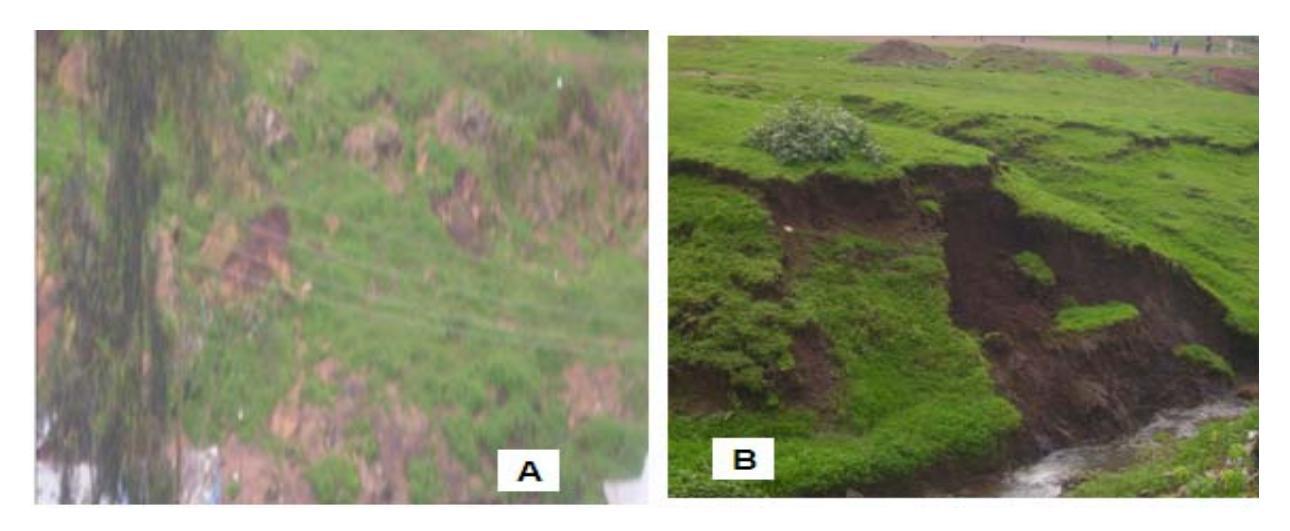
Fig-4.1 Rugged, large slope and impervious surface in Yeka sub-city (source: Field survey 2009).

i. Topography and Geological formation: This includes rugged terrain, larger slope/gradient, high elevation and impervious rocky surfaces. These are the major barriers in managing the urban storm water drainage system in the sub-city. Because its ruggedness and larger slope needs a complicated and highly engineered designs, which on the other hand requires additional financial sources to effectively employ such high level practices. Besides, due to the highly impervious layers as a result of rocky nature of the area, mainly in some hilly parts of Yeka, the rain fall does not infiltrate in to the ground. This result in reduced ground water recharge and lower survival rate of planted plant species leading to both accelerated water and wind erosion.

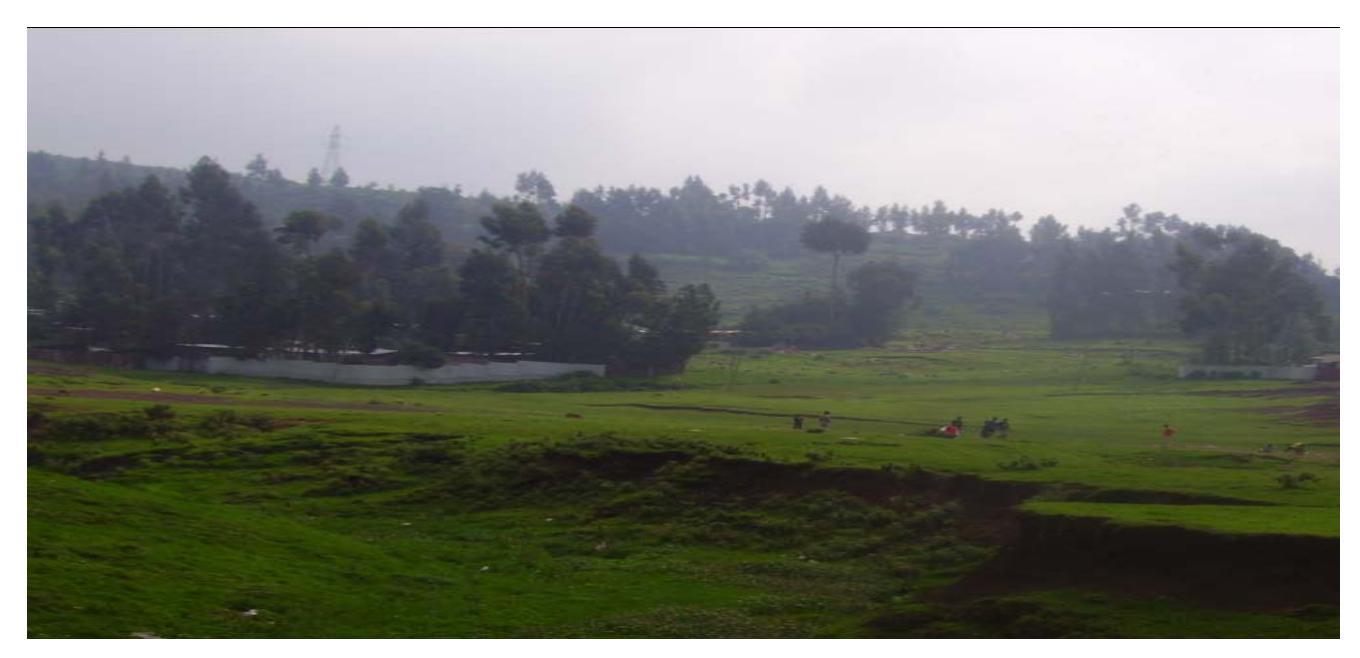
Fig-4.2 Sparsely vegetated part of Yeka sub-city kebele01/02(source:Field survey August, 2009).

ii. Less vegetation cover on Yeka Mountain: this is the other major challenge, particularly in the hilly parts of the sub-city. About 3,566 ha (45%) of the sub-city is reserved for green area or in other way this is not recommended for settlement, but most of the reserved areas are illegally utilized for unauthorized function/uses such as quarrying, informal settlements and farming activities and hence there is a serious problem in managing the storm water drainage system in the sub-city due to: inadequate forest/tree, inadequate soil and water conservation activities, loss of indigenous trees, lack of appropriate tree species-which can have the capacity to hold soil through their roots and improper land use that is reserved forest lands are illegally encroached for other purposes. Figure-4.2 is a notable evidence to this phenomenon.

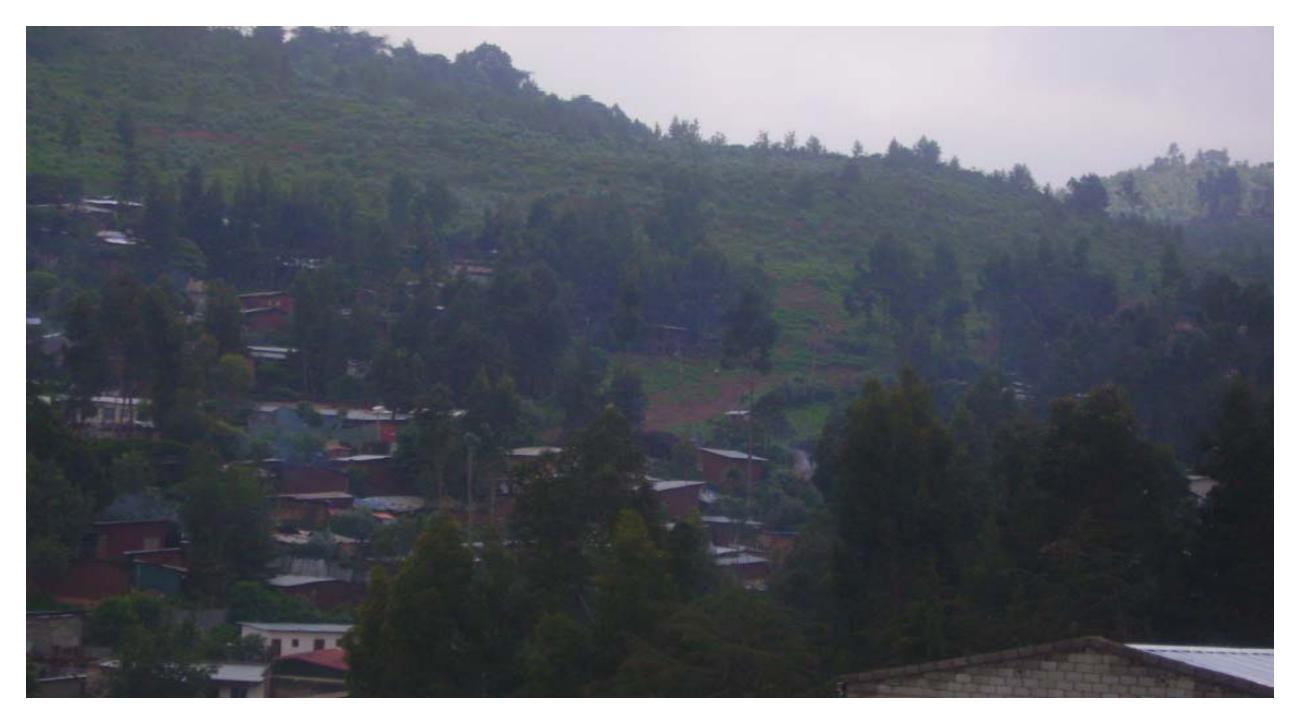
Fig-4.3 llegal settlements on Yeka mountain kebele08/15 (source:Field survey August, 2009).

iii. Informal settlement: this is the biggest challenge in managing the drainage system in this sub-city, because the area reserved for forest is encroached by informal settlement. This has exacerbated the land degradation/erosion problem due to the increased flooding as a result of impermeable surfaces, illegal solid and liquid wastes disposal in to existing natural water ways and drains. Figure-4.3 is an evidence to this reality.

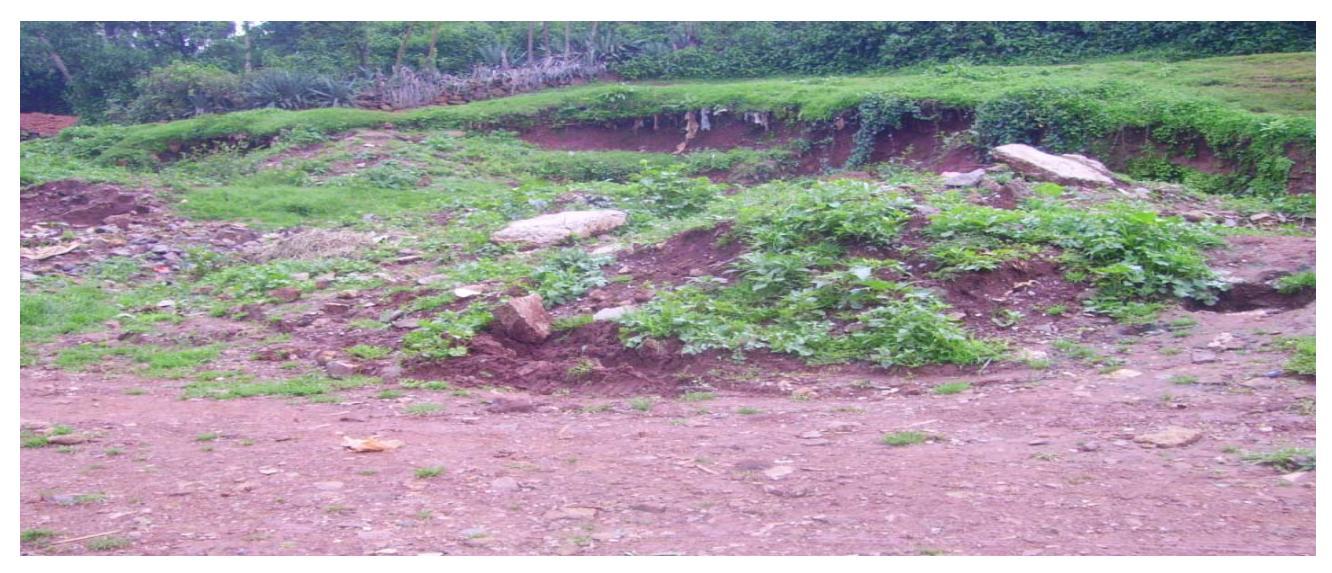
Fig-4.4 Illegal quarrying in Yeka Sub-city kebele08/15(source: Field survey August, 2009).

iv. Illegal quarry activity: In a similar way the area reserved for greenery is turned in to illegal quarrying. This illegal quarrying particularly on the hilly parts of the sub-city aggravates the land degradation and flooding problem. The features of such illegal quarrying activities are depicted in Fig.4-4.

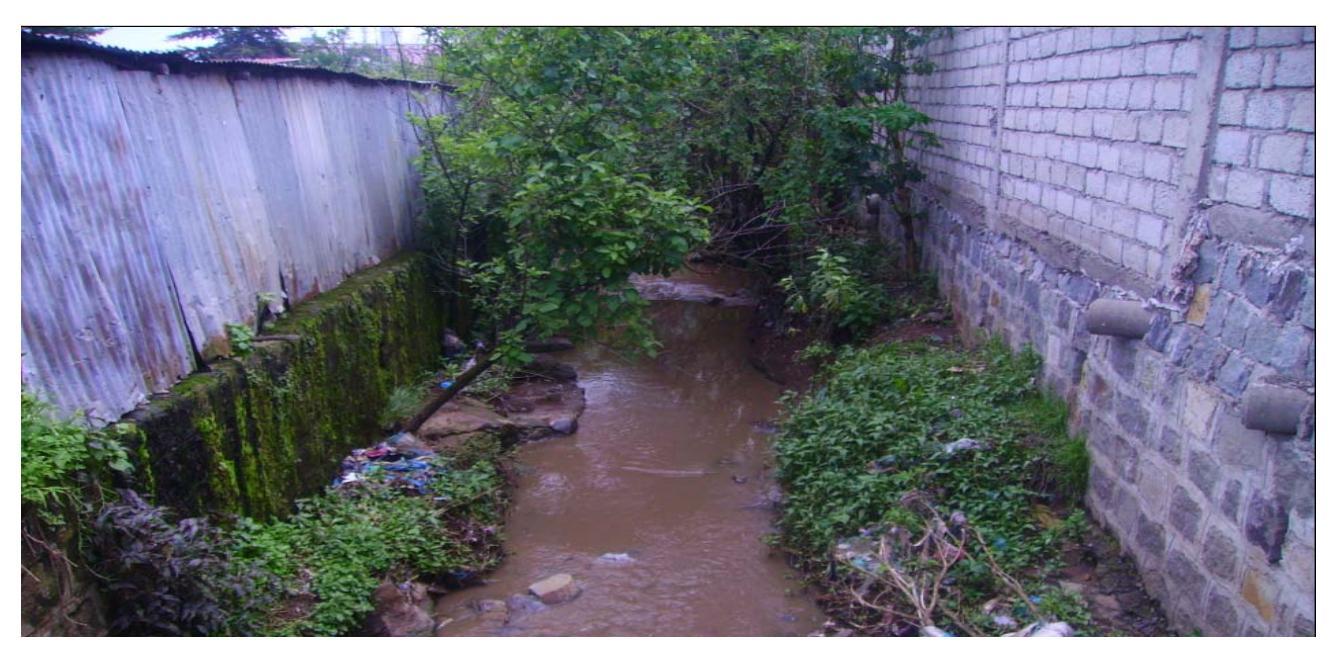
Fig-4.5 A river without a buffer zone (source: Field survey August, 2009).

v. Absence of River buffers around natural water ways: Although the Addis Ababa Environmental Protection Authority has set a regulation on buffer zones of rivers to be kept 15m to 30m from the center of the river on both sides, most of the river banks/buffers are encroached by illegal settlements and/or functions. This in turn has widened the river bank through water erosion and land sliding, which then decreased the productive urban land which may be used for other productive land use functions. Figure-4.5 is a good evidence to this.

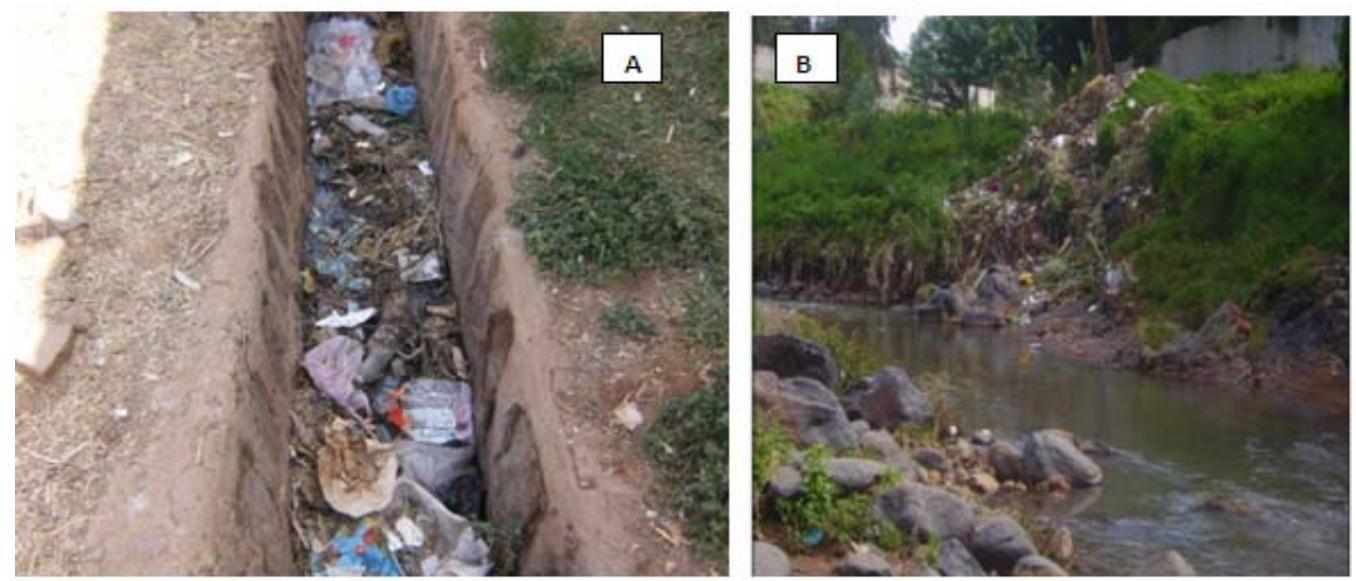
Fig-4.6 solid waste dumped in to storm water drains (A) & rivers (B) Kebele 01/02 (source: field survey August 2009).

(Including demolished materials, soil, house refuses plastic materials and others): This has been aggravated the problem of flooding. This is to mean because of dumped solid waste in to the existing natural water ways and urban drainage facilities the flood over flows and create a problem on residents and other urban infrastructure and utilities. According to the Addis Ababa sanitation and beautification agency, it is nearly 60% of the total solid waste generated from various sources has a proper management. This implies that the other 40% is dumped in to open spaces or unauthorized places including natural water ways and drains. Figure-4.6 confirms this truth.

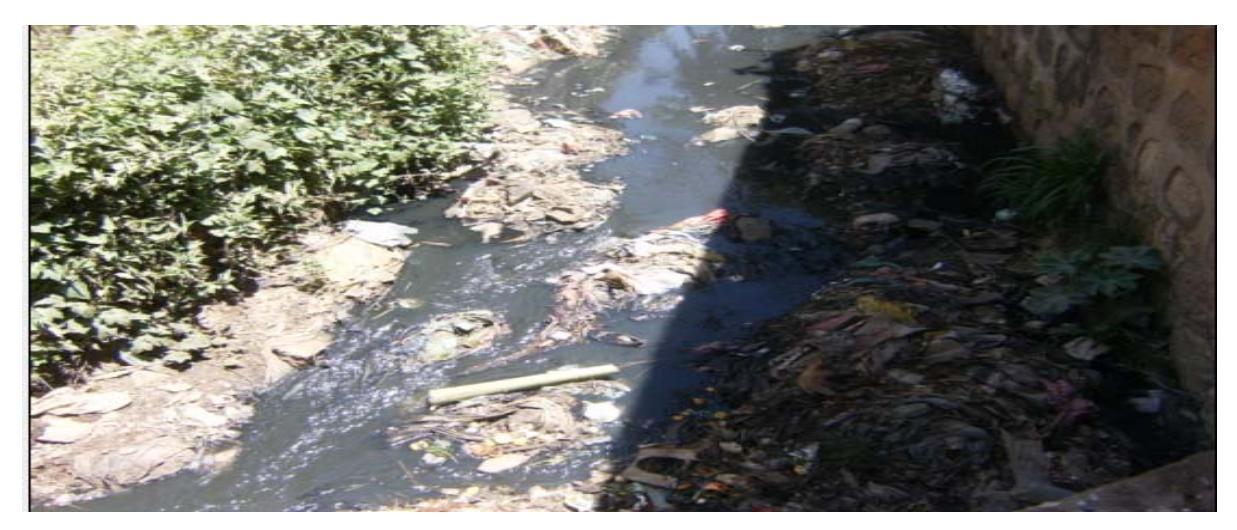
Fig-4.7 Natural water way full of wastes Kebele 13/14 (source: field survey May, 2009).

vii. Discharge of liquid wastes in to existing water ways and drains: Illegal connection of sewerage system in to existing drains and natural water ways is one of the challenges which have been observed in the sub-city. Most of the drainage lines in Yeka sub-city serve as a sewer and are blocked by liquid wastes; Figure-4.7 is one of the evidence for such illegal activities.

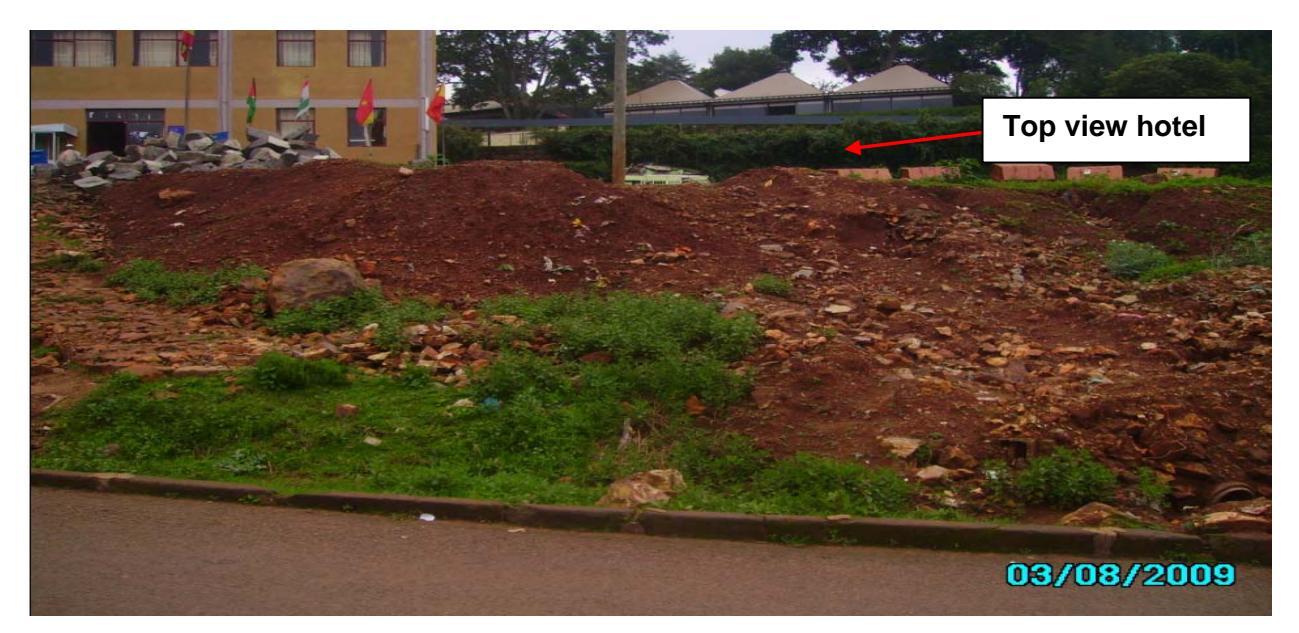
Fig-4.8 Housing development that disturbs the drainage system kebele 08/15 (source: Filed survey, 2009).

ix. Infrastructure development (or construction sites) does not consider the existing drainage system: - the majority of infrastructure development in the subcity has no attention to the drainage system. For example, housing construction, road construction and upgrading, water supply lines and telephone line installation and expansion have been degrading the urban drainage system and have found that they are the major causes of land degradation and erosion. Figure-4.8 is a notable one.

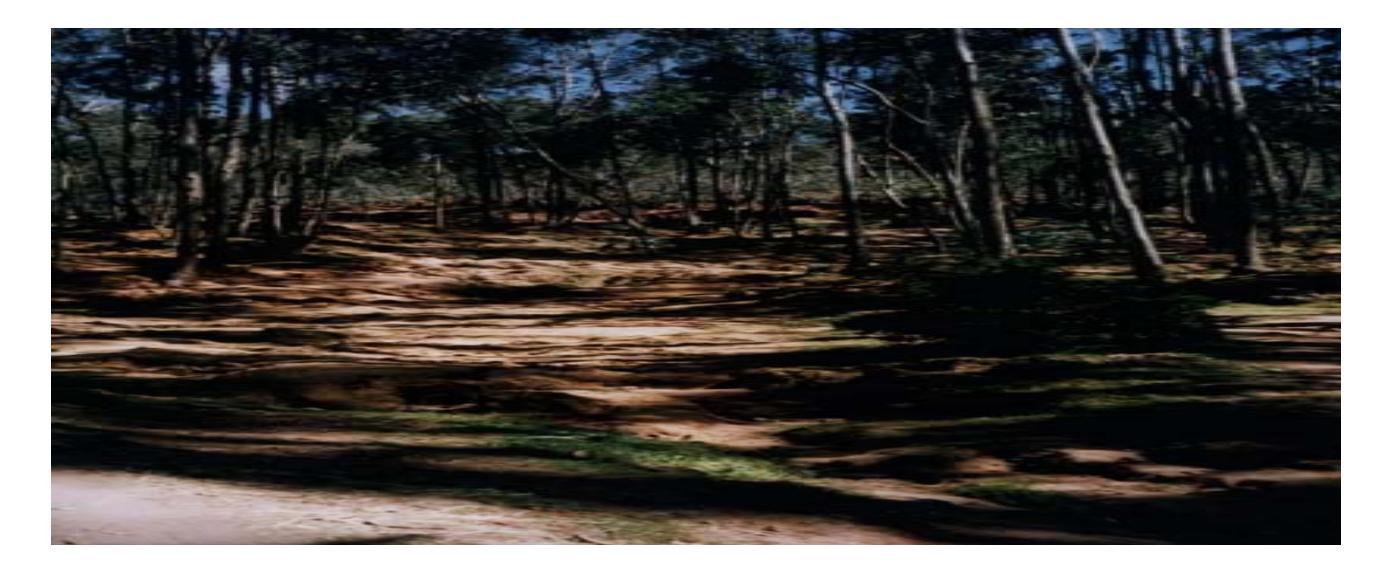
Fig-4.9 Land covered by eucalyptus tree and exposed to erosion kebele01/02.

Yeka Mountain is relatively bare and predominantly covered by eucalyptus tree, which does not allow other shrubs and grasses to grow underneath due to its high competition to water and nutrients. Fig-4.9 is evidence to this.

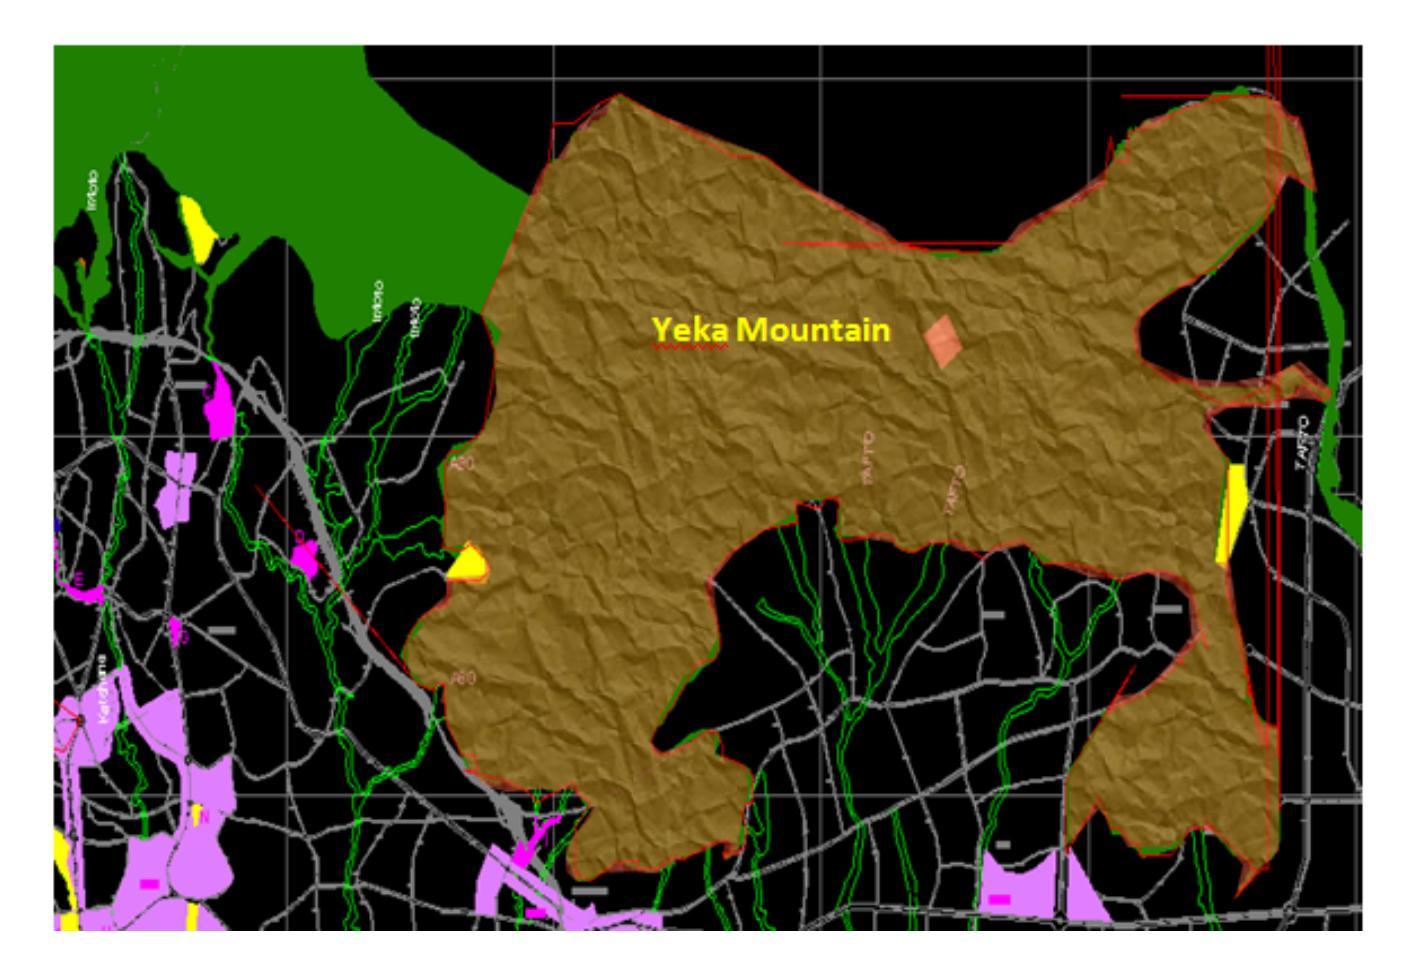
Fig-4.10 Yeka Mountain (source: AAEPA, September 2009)

The Area (A) of Yeka Mountain, which has a direct environmental impact on the Yeka sub-city as indicated in fig-4.10 is calculated (using AutoCAD and GIS soft wares) and found to be 3,566ha. This value was considered to calculate/estimate the total amount of runoff entering in to the sub-city.

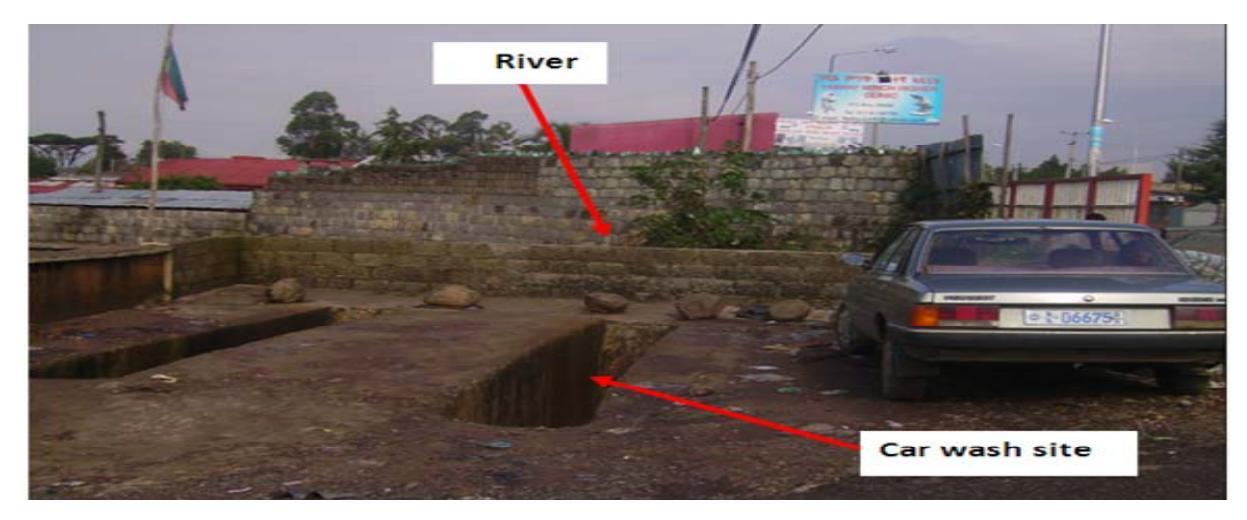
Fig-4.12 Car wash site that discharge its spent in to a river (source: filed survey May, 2009).

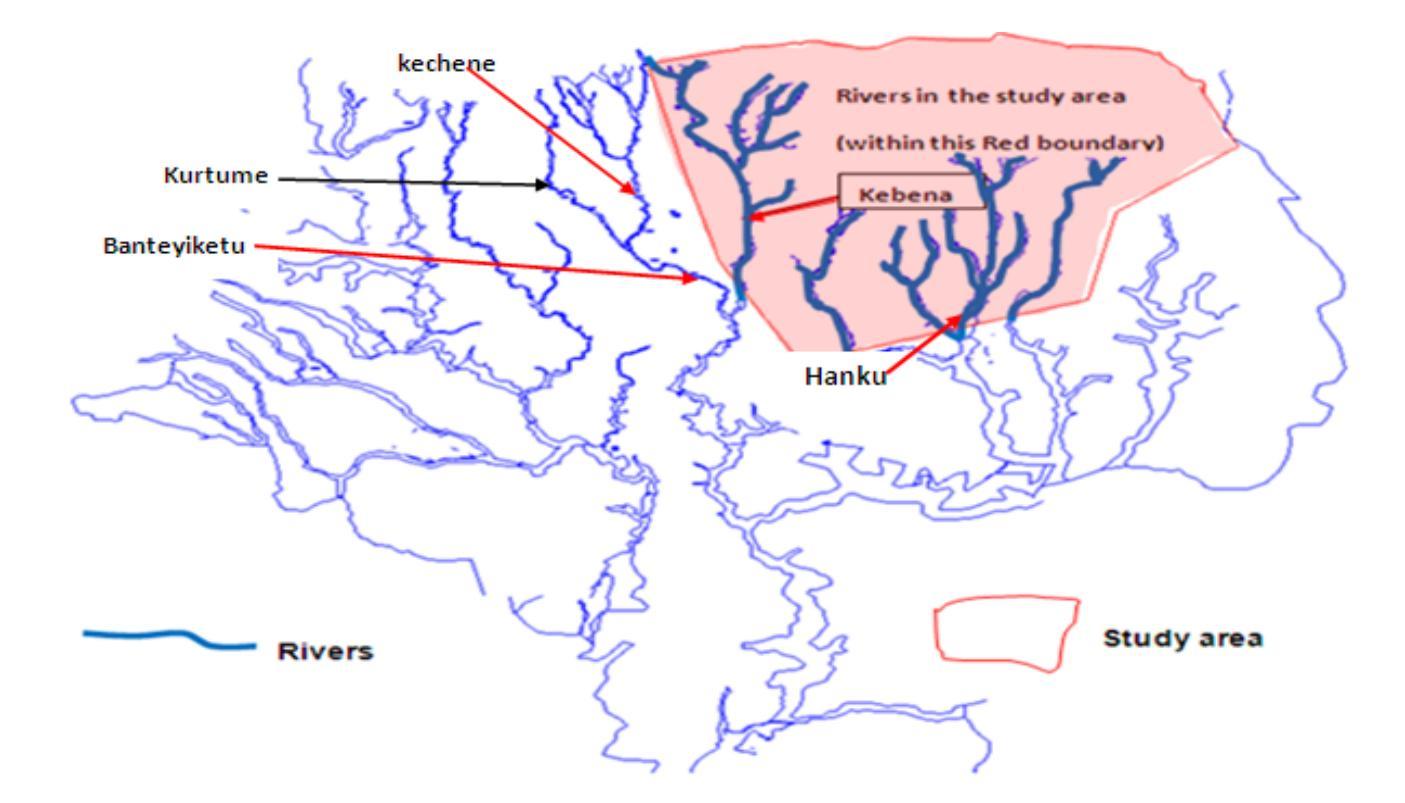
Fig-4.13 River systems in Addis Ababa and the study area(source: Addis Ababa EPA and AutoCAD analysis)

Addis Ababa is located in the uppermost catchment area of the Awash River basin. The catchment area of the Rivers in the study area is part of this river basin and is represented by the Kebena river system. Figure-4.13 depicts all the river systems in Addis Ababa and in the study area, which is enclosed within the red boundary.

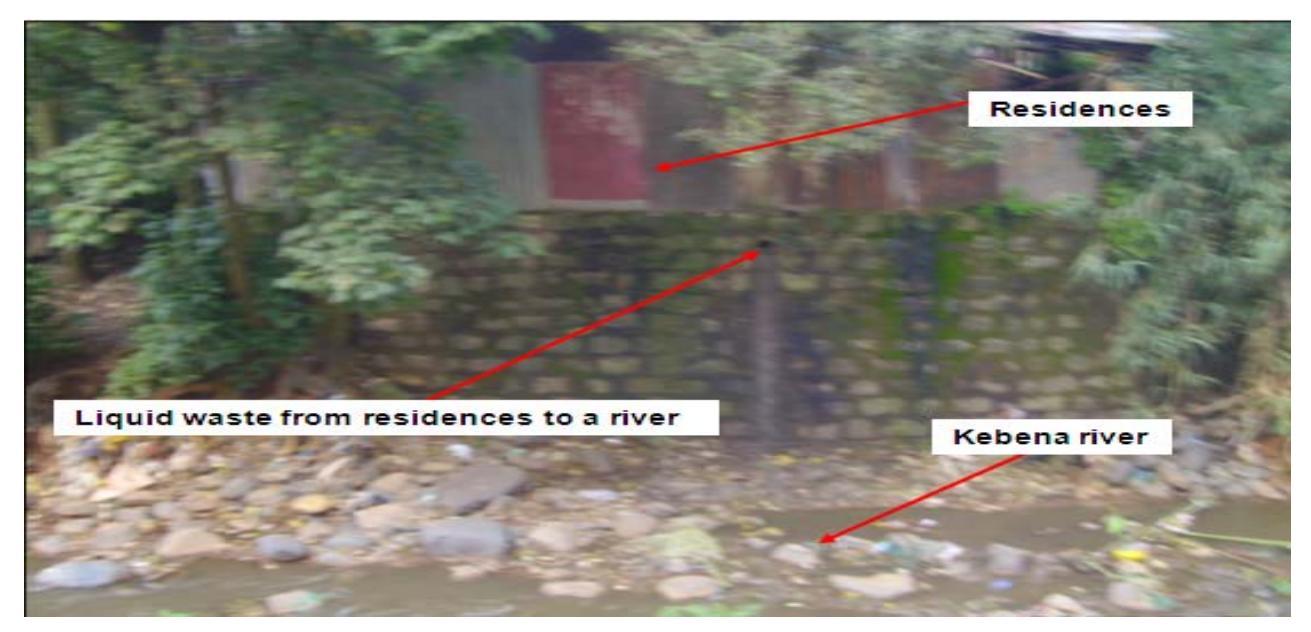
Fig.-4.14 Encroached river by illegal settlement kebele 08/15 (source: Field survey, 2009).

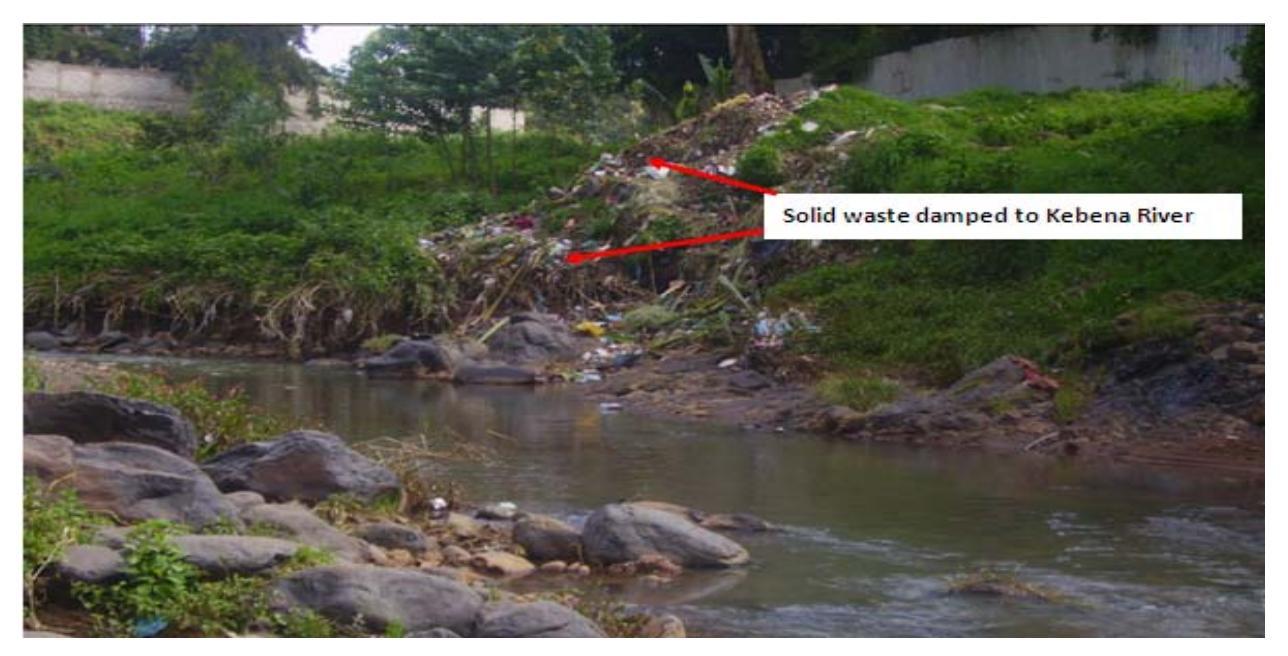
Fig-4.15 Solid waste damped in to Kebena River (source: Field survey, 2009).

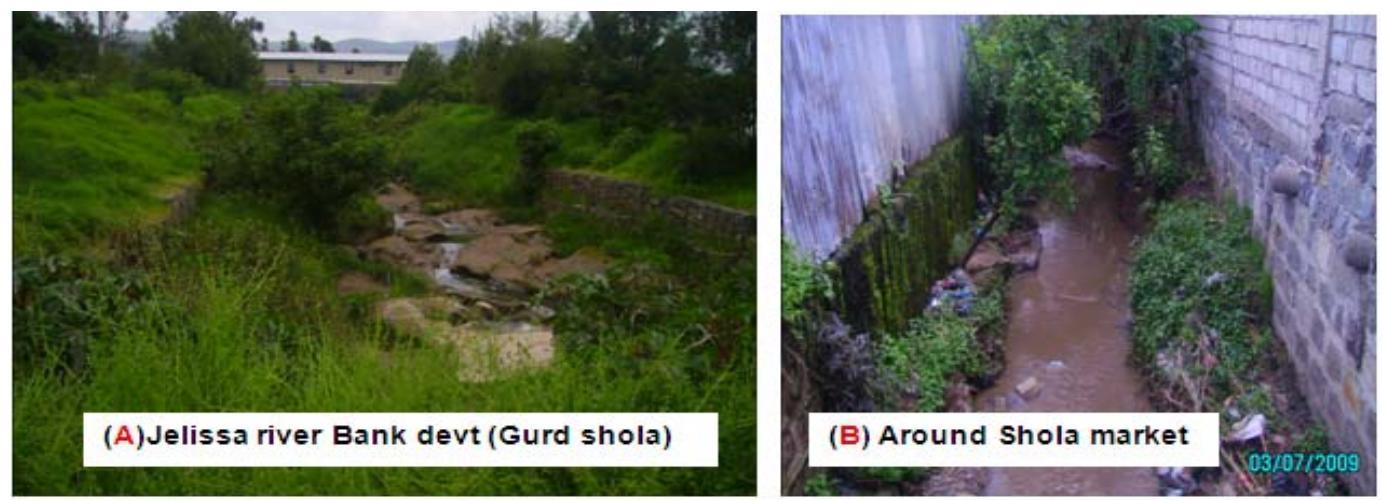
Fig-4.16 Comparison between a river with(A) and without(B) buffer zone (source field survey, 2009)

On the other hand, the Addis Ababa Environmental protection Authority has one river buffer zone demonstration site, which is Jelissa river bank development project. This pilot program has changed the general existing condition of the river to become more attractive. Along with its environmental benefits, it contributes considerable values in to the surrounding community. Figure-4.16 is one of the interesting result of this river bank development on Jelissa river around Gurd Shola-adjacent to Lucy Academy or left to the way of office of Addis Ababa Environmental Protection Authority. Furthermore, to show the effect of a river with and without buffer a pictorial comparison has presented in Fig-4-16.

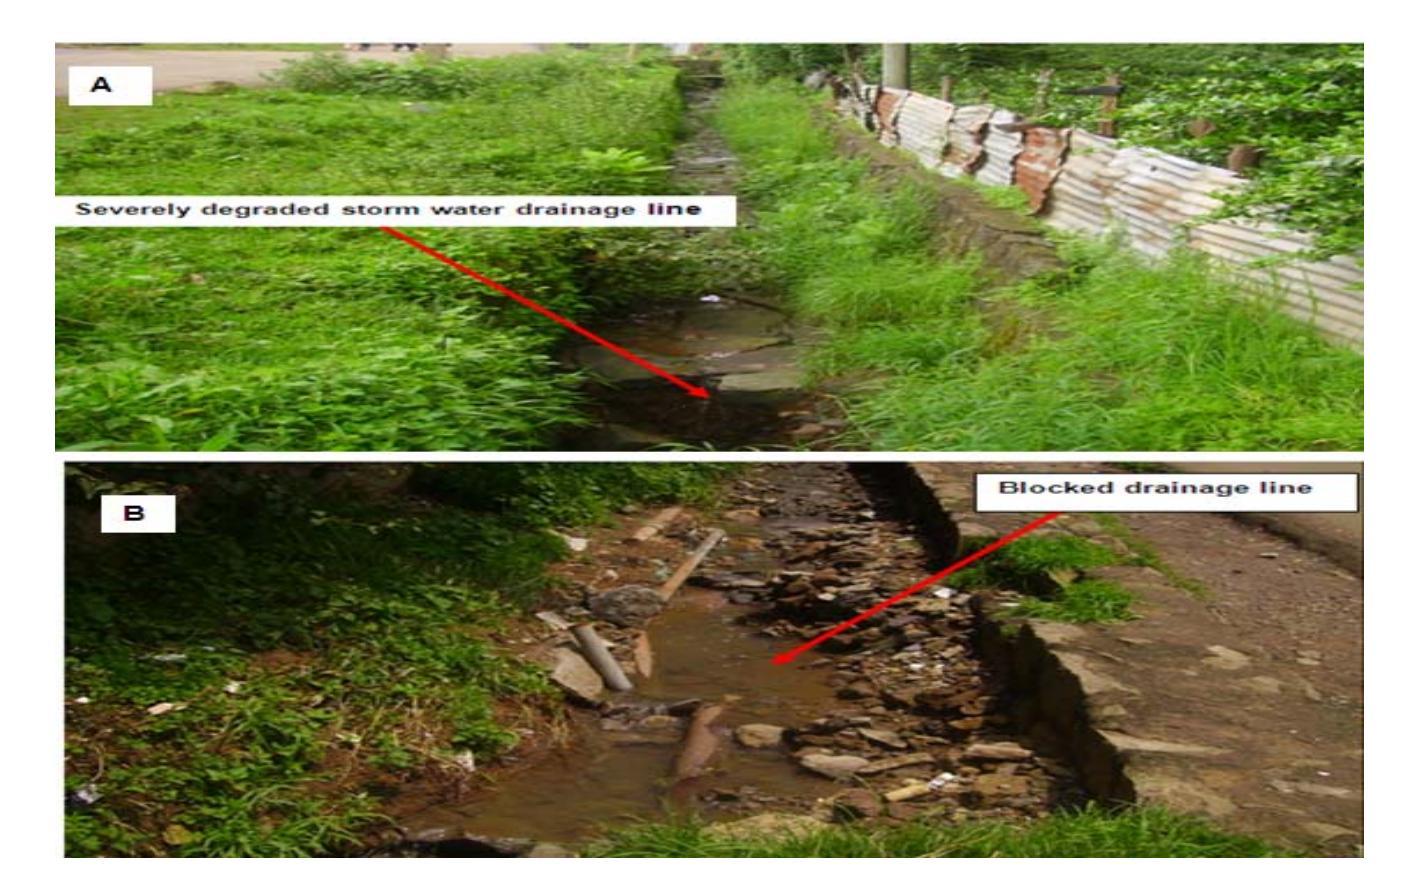
Fig-4.17 Severely degraded storm water drainage lines kebele o1/02(source: Field survey, 2009)

From Table-4.9, of the total drains in the three sample kebeles about 45.52% is severely degraded, which has resulted in degradation of road and other urban utilities as evidenced by Fig.4-17.

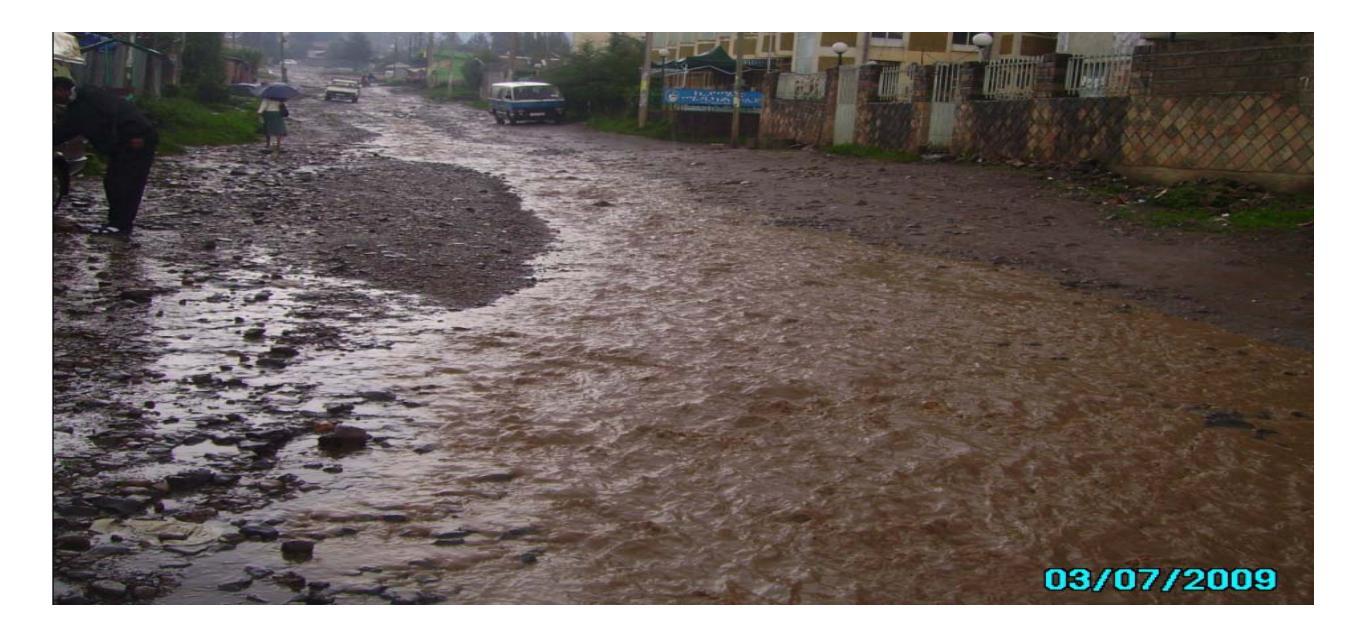
Fig-4.18 Flood over flowing on road surfaces kebele13/14 (source: Field survey, 2009).

Generally, in the sub-city the flood generated during the rainy season could not safely be discharged in to the final receiving natural water ways. That is why, during field survey (in the time of rain event) it was common to observe runoff (flood) that flows over the surface of roads and other urban utilities-this is evidenced by Figure-4.18.

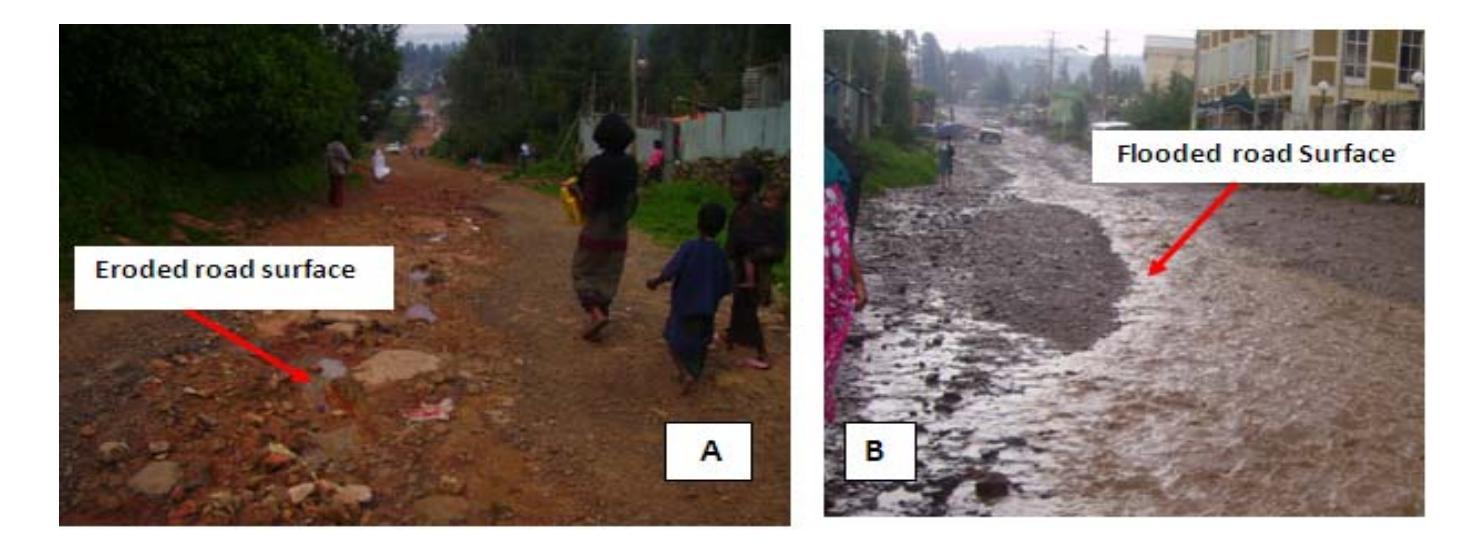
Fig-4.19 Highly eroded (A)and flooded road(B) surfaces (source: Field survey August, 2009).

Generally, of the total roads in the three sample kebeles 14.44% is good, 52.17% is light and 21.15% is severe. Light and severely degraded roads together comprises of 73.26%. As it was critically studied during field survey almost 90% of the deteriorated and degraded and/or eroded roads have occurred due to the absence of adequate urban storm water drainage infrastructure that discharges the flood generated safely in to the final receiving systems. Figure-4.19 "A" and "B" are notable examples to this truth.

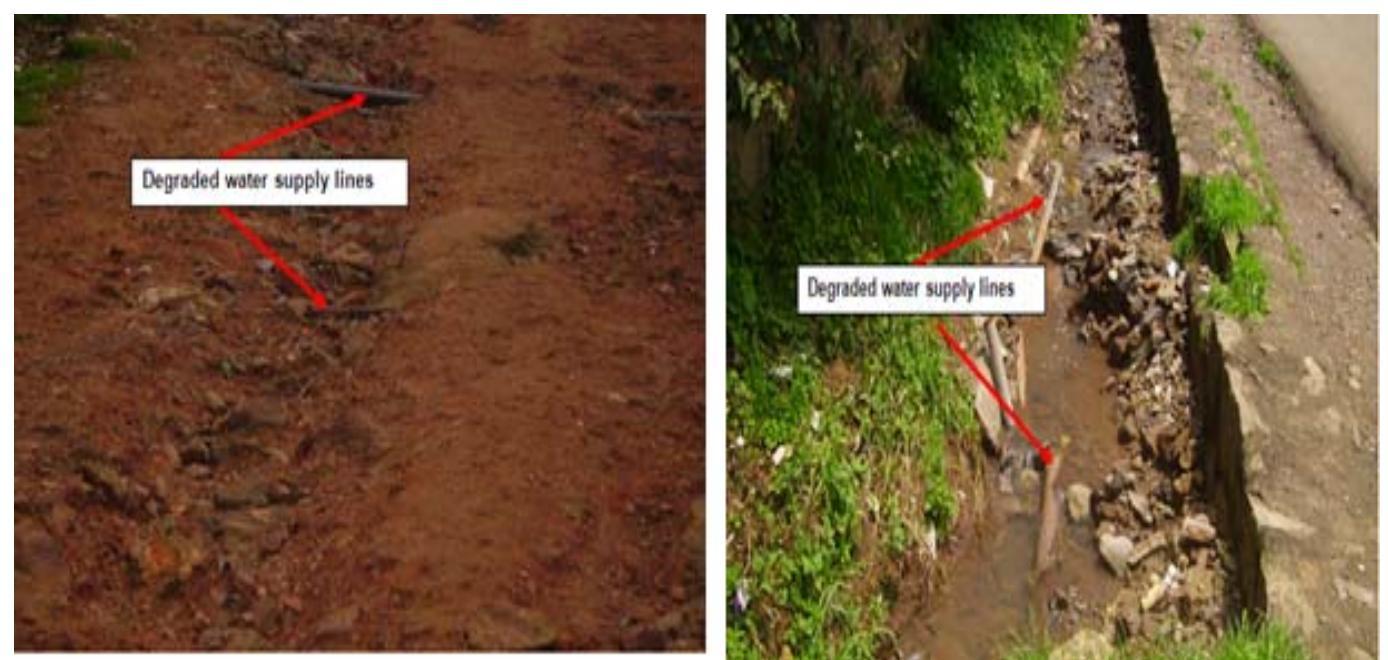
fig-4.20 Degraded water supply lines (source: Field survey, 2009).

From the field survey it was evidenced that water supply lines, telephone lines, bases of residences' foundation and other buildings have seriously degraded due to the inadequate urban storm water drainage provision and management. For example in kebele 08/15 water supply lines and road bases have seriously degraded-as depicted in Figure-4.20.

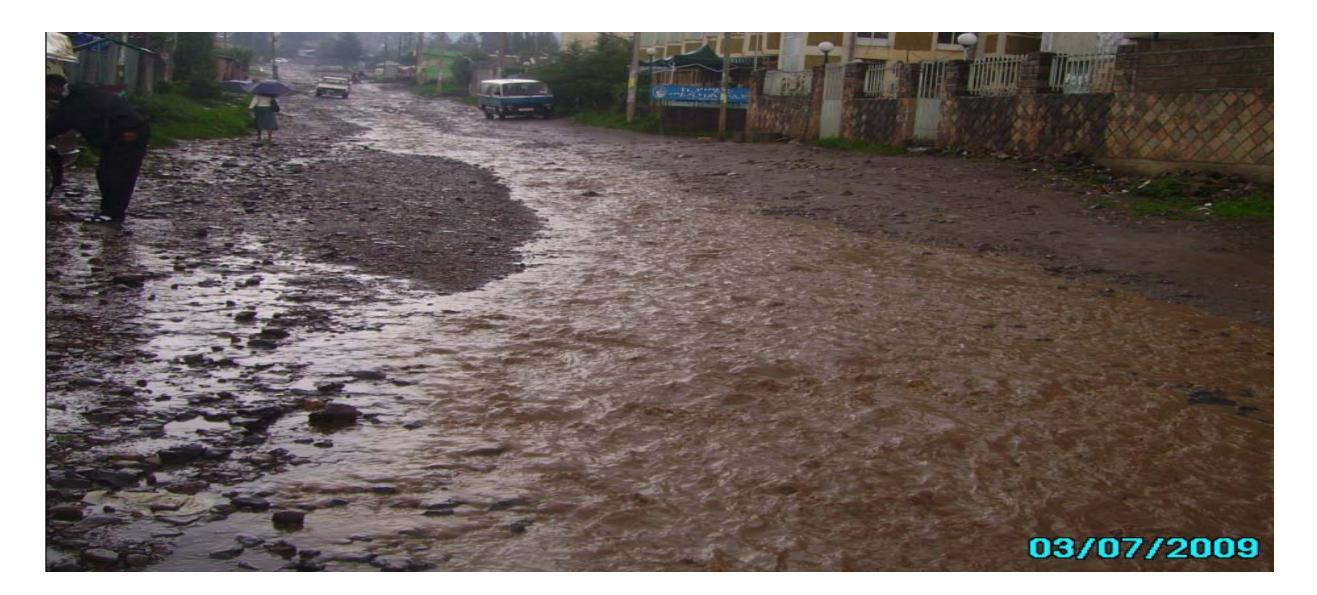
Fig-4.21 Flood flowing over the surface of roads (source: Field survey August, 2009).

In many parts of the study area flood over flows on the surface of roads during rainy events. For example, in kebele 13/14 it was observed that accelerated and concentrated flood was flowing over the surface of a road, which is evidenced by Figure-4.21.

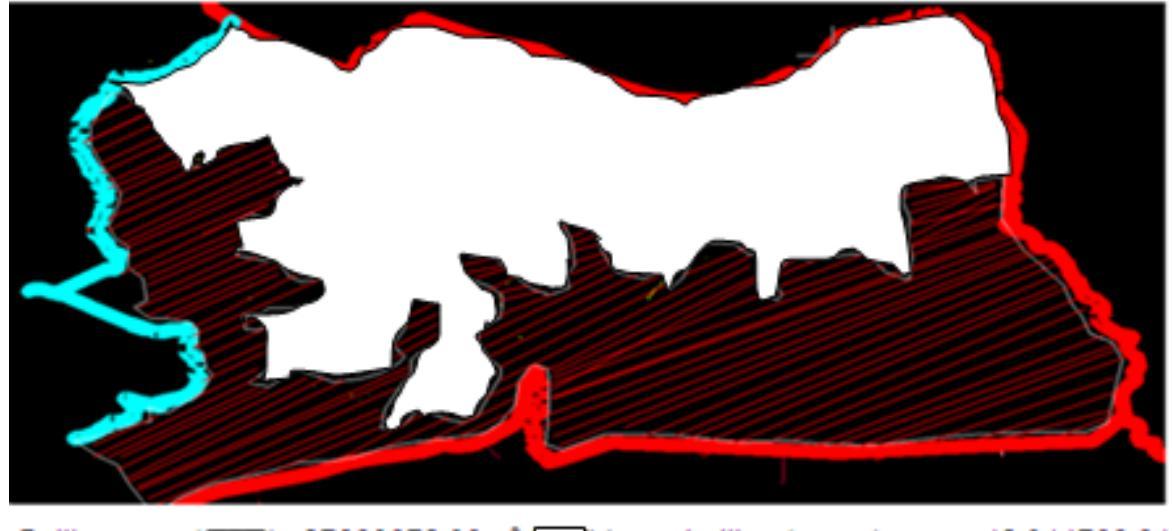
Built-up area() = 37689073.90m²)) non-built up(green) area = 43,911708.61m² total=81,600,782.51m².

Fig-4.22 Shows the built-up and non-built up area of Yeka sub-city (source: own analysis)

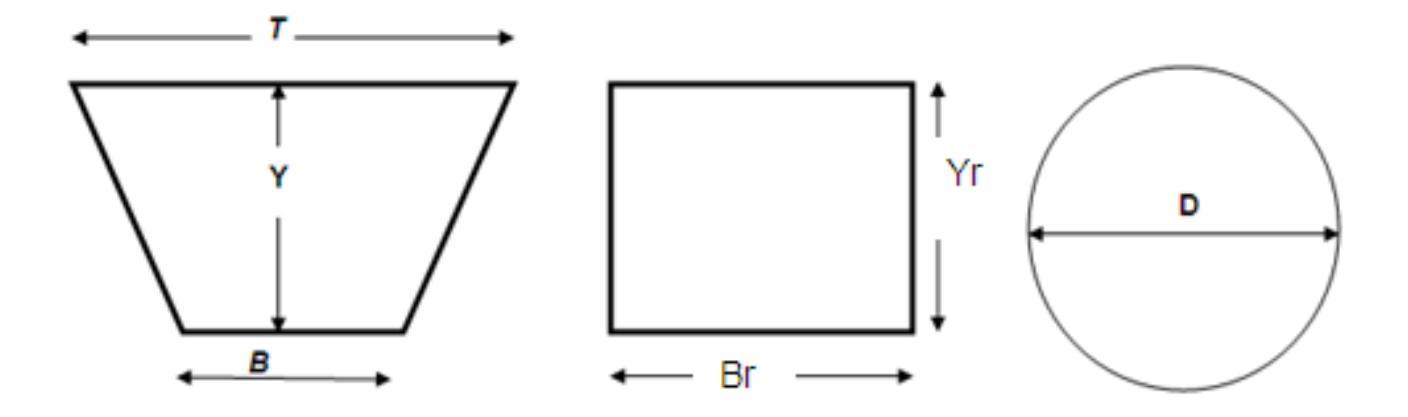
Fig-4.30 The three alternative urban storm water drainage line shapes with their dimension designations.

- Diameter of a Circular drain, D=Dp+ free board ------ (34)
 The free board is added in a way similar to that of the depth of Rectangular and Trapezoidal drain.

- Area of pipe/circular drain, Ap=3.14*Dp²/4 ------ (33)
- Speed of flood or storm water (V)= 0.77* Q/A_p ------ (34) where 0.77 is used to compensate or balance the effect of retarding materials like weeds, sediments and the like when storm water travels within a drain.
